# Airworthiness Directive of The Netherlands

**BLA nr. 1993-040/4**

**Ball and Socket Connectors**

**EQUIPMENT & FURNISHINGS - BALL & SWIVEL JOINT LOCK PLATES - INSPECTION/MODIFICATION**

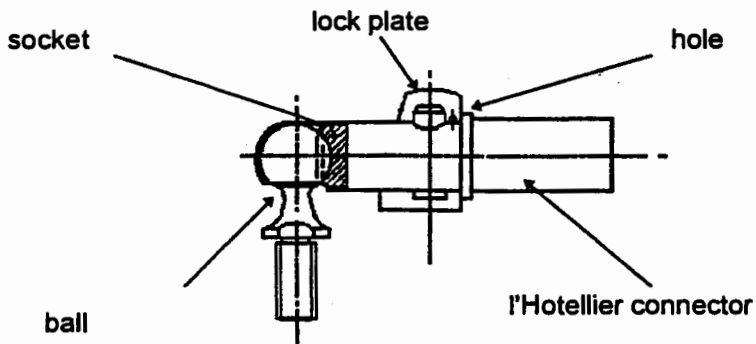
If the connectors are not yet equipped with safety pins (e.g. I'H 140-31 made by Hotellier), these safety pins have to be retrofitted. In certain cases it may become necessary to rebores the hole in the lock plate, which is provided for visual inspection, to  $\varnothing 1.2$  mm so that the safety pin can be inserted.

Unsecured ball and socket connectors may open automatically in flight!

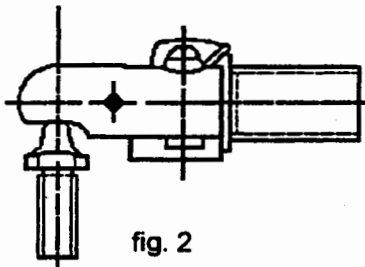
fig. 2

The following systems to secure l'Hotellier ball and socket connectors are LBA-approved: Uerlings sleeves or Uerlings type sleeves (see section III), safety pin (figures 2 and 2a), LS-safety sleeve (figure 3), Schempp-Hirth spring (figure 4) und Wedekind locking system (figure 5).

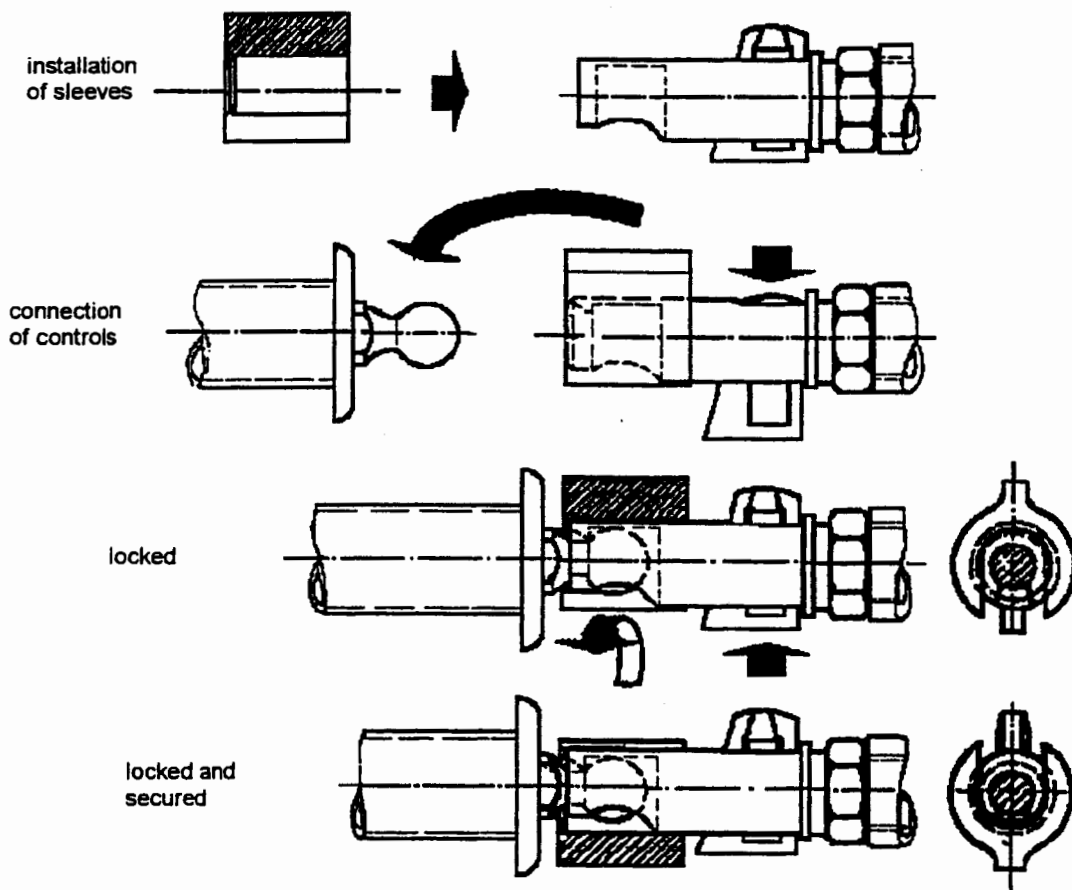
They may by no means be clipped radially onto the l'Hotellier ball and socket connector. Radial clipping (excessive opening of the sleeve) may lead to cracks or ruptures due to overstressing so that the sleeve cannot function properly any more.

For installation, the sleeves have to be slid axially onto the l'Hotellier ball and socket connectors.

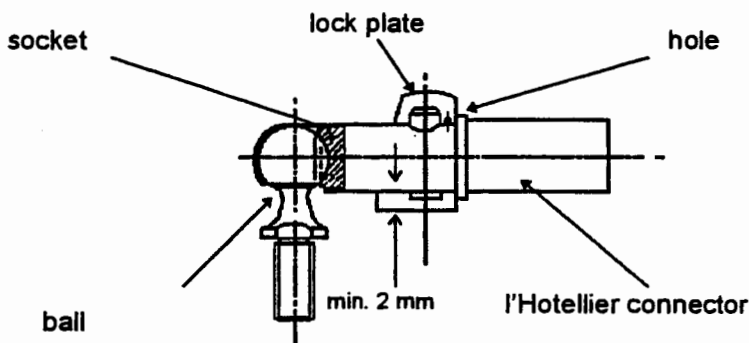
The socket is to be slid completely over the ball with the lock plate pressed down. During locking the lock plate moves back slightly so that in a correct connection the hole on the narrow edge of the lock plate becomes visible.

By loading the connection full engagement of the ball is to be verified!

Unsecured ball and socket connectors may open automatically in flight.

The safety pin is to be inserted in this hole thus securing the ball and socket connector.

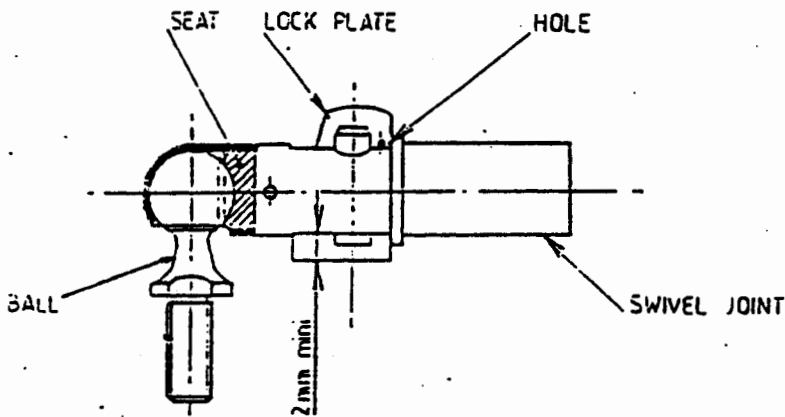
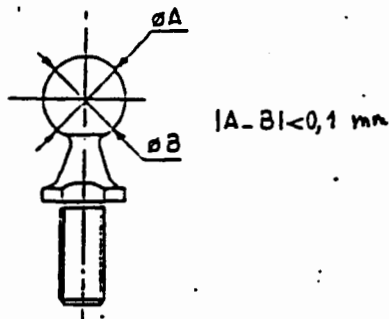
The variation between several measures of the ball diameter must not exceed 0,1 mm.

This projection must be higher than 2 mm.

If after these verifications, one of the above check is out of tolerance, it is mandatory to replace both ball and swivel.  
nevertheless it is recommended to replace this assembly every 10 years or every 3000 flight hours.
